GS & TJ Services

Property Inspection Report

1234 Main Street, Flossmoor IL, 60422 Inspection prepared for: Client Leon Inspection Date: 7/19/2012 Time: 11:00am Age: 58 yrs Size: 1,930 sq ft

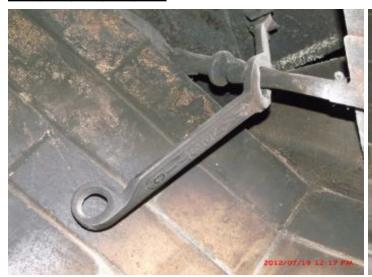
Fireplace damper handle

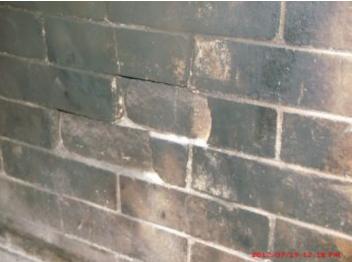
Some Fireplace brick deterioration

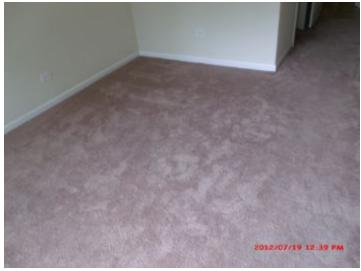
Carpet loose in the rear west bedroom

Master bedroom carpeting

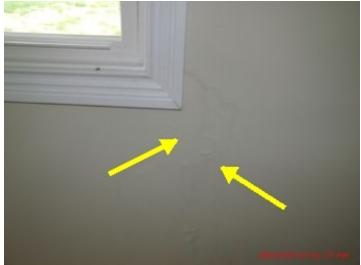
Bedrooms		
Page 9 Item: 12	Wall Condition	There is evidence of moisture entering structure.

Observations:
• There is evidence of moisture entering structure.

Signs of moisture leak - rear bedroom window

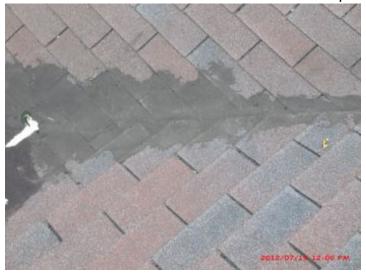
Some indication of repair in valley near flat top

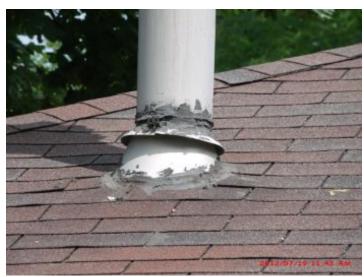
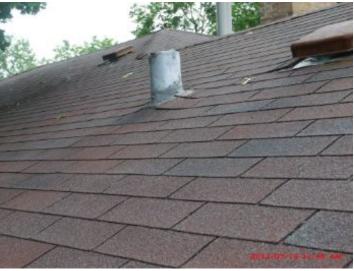
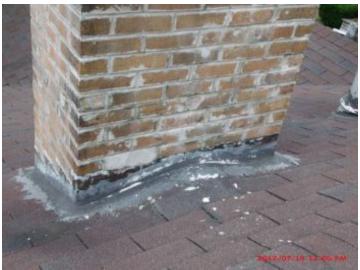
Flashing wear near chimney - suggest year maintenance

• Flashings are mastic covered, recommend re-sealing all through the roof vents and projections as a part of routine maintenance.

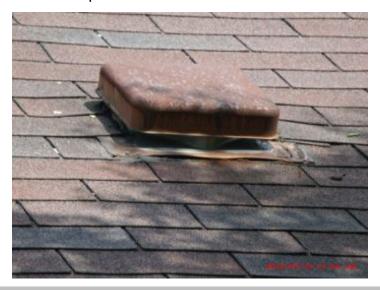
Observations:
• The vent cap is rusted.

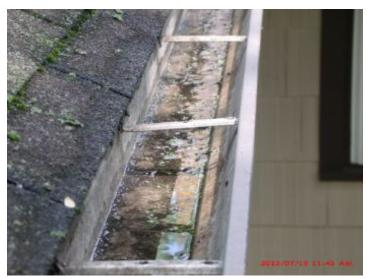
Some asphalt sand in gutter, indicative of recent roofing

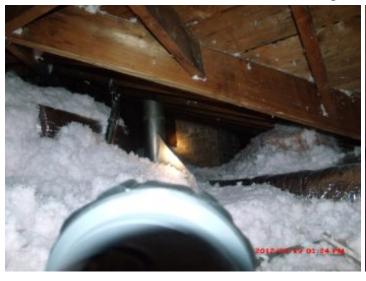
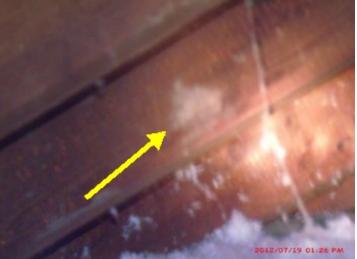
- Evidence of past or present leaks, dry at time of the inspection. Monitor for leaks &/or have roofing contractor evaluate.
- Evidence of past leaking noted. The area tested dry with a moisture meter. Recommend monitoring for future leaking.

Evidence of past moisture

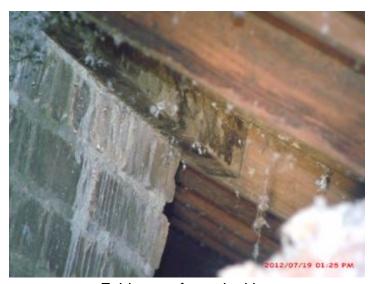
Evidence of past leaking

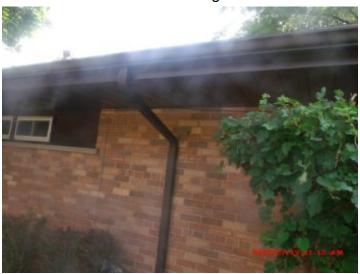
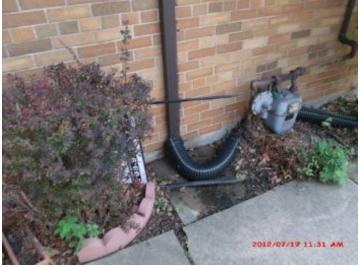
• Downspouts with missing extention. Rain water deposited near foundation, causing water intrusion into basement

Extended downspout at front left (southwest)

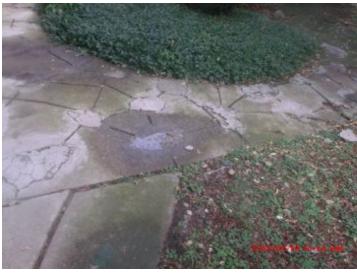
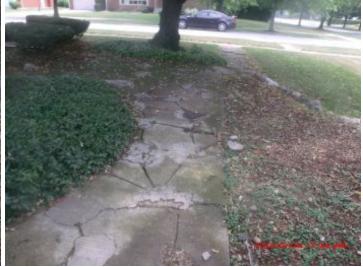
Concrete walkway cracks and patches

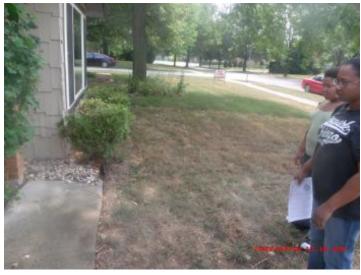
Front graded generally away from foundation

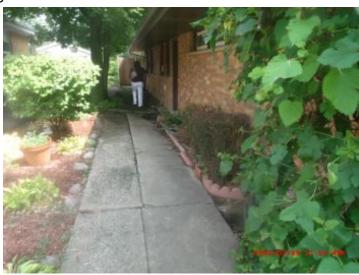
Left (west) side sidewalk graded towards house

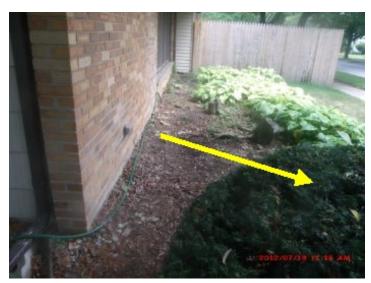
right (east) side graded generally away from foundation
