## **GS & TJ Services** Property Inspection Report

1234 Main Street, Flossmoor IL, 60422 Inspection prepared for: Client Leon Inspection Date: 7/19/2012 Time: 11:00am Age: 58 yrs Size: 1,930 sq ft

# **Inspection Details**

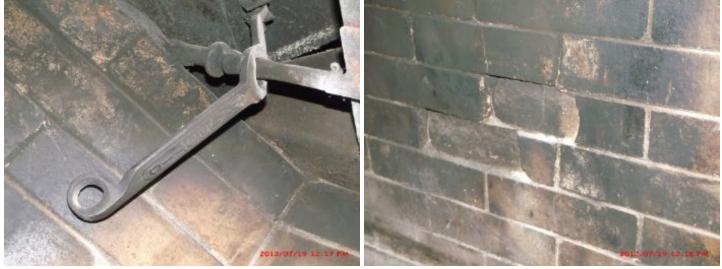
Fireplace damper handle

Some Fireplace brick deterioration

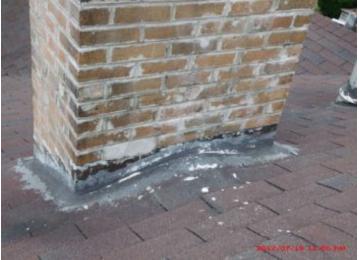
Flashing wear near chimney - suggest year maintenance

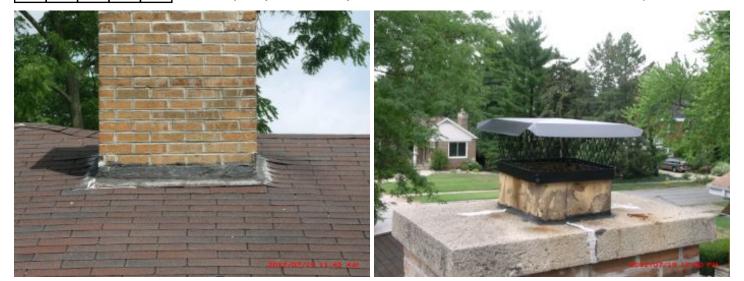
Firepace Chimney cap

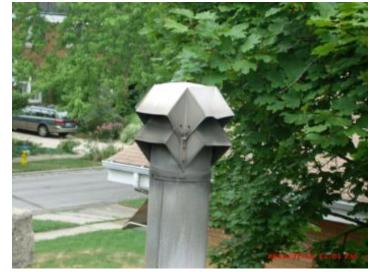
#### Furnace chimney cap

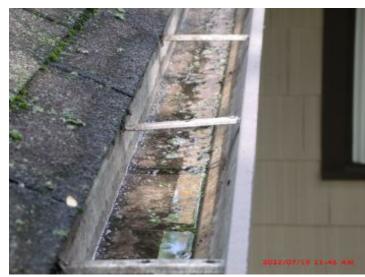
Some asphalt sand in gutter, indicative of recent roofing

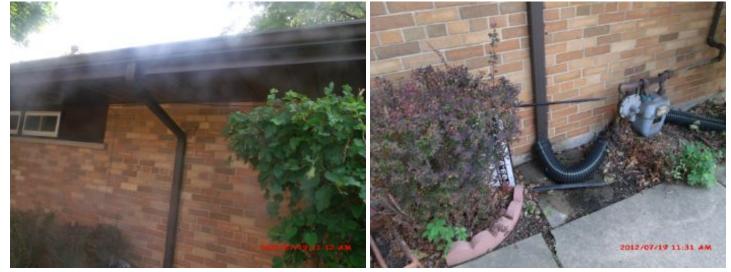
• Downspouts with missing extention. Rain water deposited near foundation, causing water intrusion into basement

Extended downspout at front left (southwest)

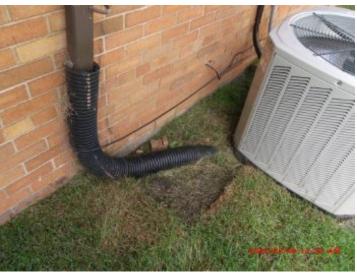
Downspout in rear appears to be blocked. Suggest opening up to deposit away from building

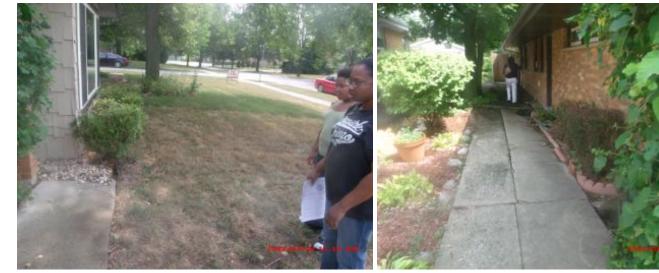
because of the direct and indirect damage that moisture can have on the foundation. It is very important, therefore, that surface runoff water be adequately diverted away from the home. Lot grading should slope away and fall a minimum of one (1) inch every foot for a distance of six (6) feet around the perimeter of the building.

Front graded generally away from foundation

Left (west) side sidewalk graded towards house
