GS & TJ Services

Property Inspection Report

1234 Main Street, Flossmoor IL, 60422 Inspection prepared for: Client Leon Inspection Date: 7/19/2012 Time: 11:00am Age: 58 yrs Size: 1,930 sq ft

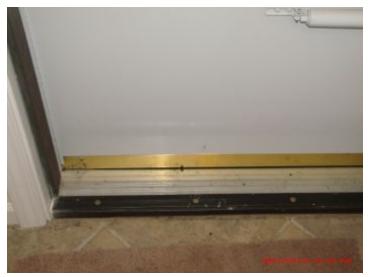
Front door sill - good condition

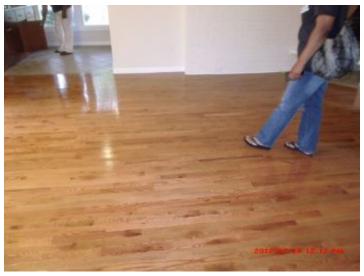
Hardwood floor living/dining room

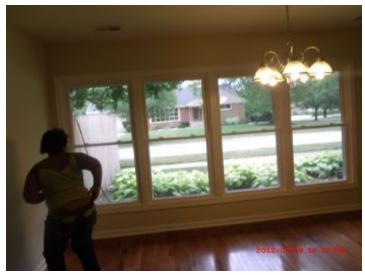
Living/dining room windows

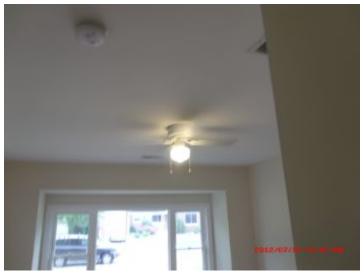
• Operated normally when tested, at time of inspection.

Master bedroom ceiling fan

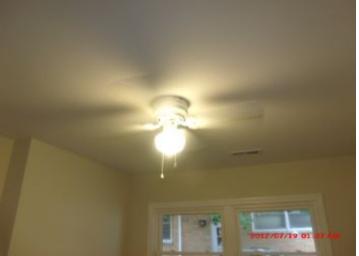
Bedroom ceiling fan

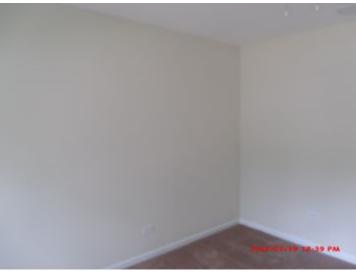
Bedrooms		
Page 9 Item: 12	Wall Condition	There is evidence of moisture entering structure.

Observations:
• There is evidence of moisture entering structure.

Master bedroom drywall

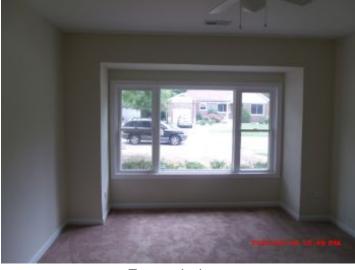
Front windows

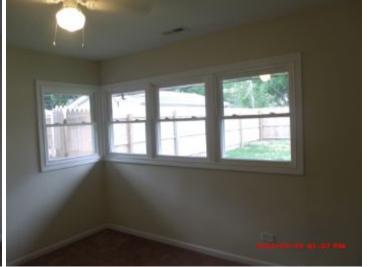
Rear bedroom windows

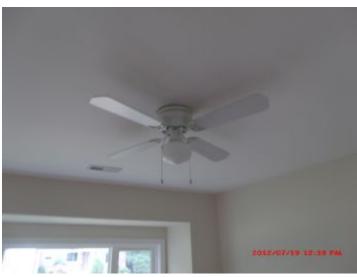
Master Bedroom drywall ceiling

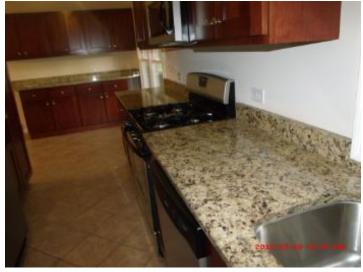
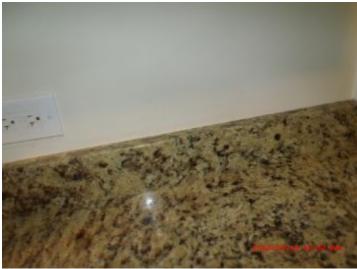
Good	Fair	Poor	N/A	None	Ol
\					Observations:
_ ^					• Granite tops noted.

Granite appearance countertop

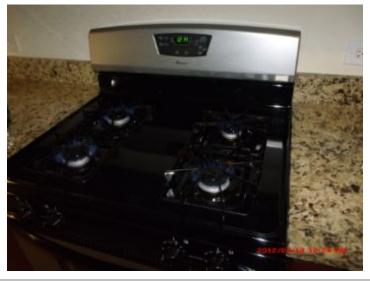
- Observations:
 Gas cook top noted.
 All heating elements operated when tested.

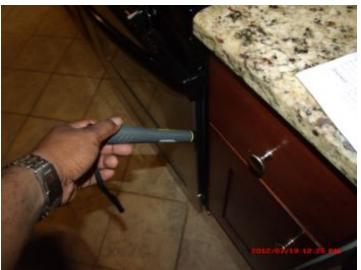
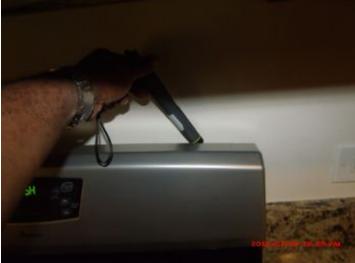
Testing for gas leaks

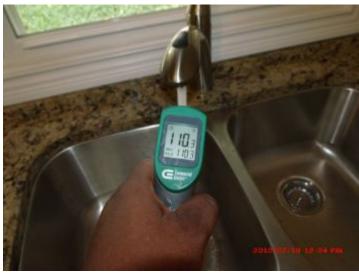
Testing hot water temperature

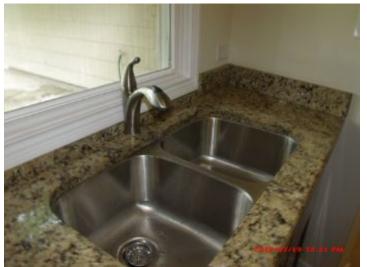
Stainless double sink

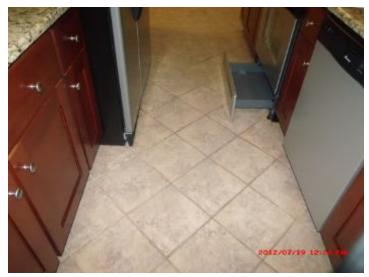
Ceramic tile new

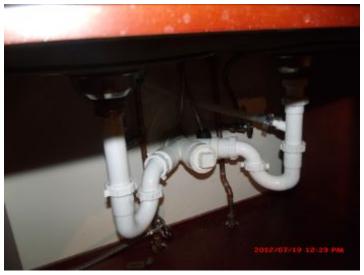
PCV waste pipe under sink

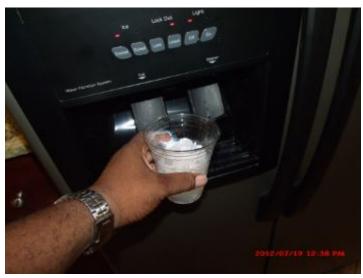
Observations:
• Tested ice cubes and crushed ice dispensers

Testing ice maker

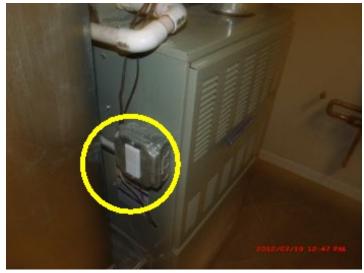
Power switch

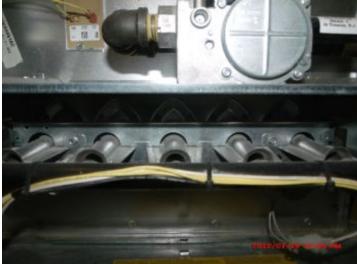
burner test

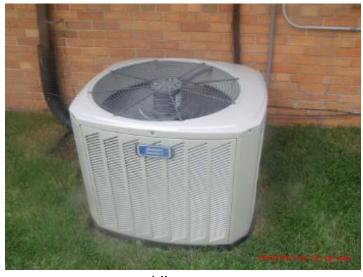
• Appeared functional at the time of inspection.

Like new

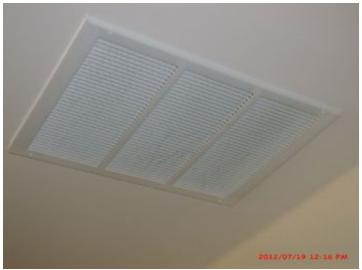
Intake register in living/dining room

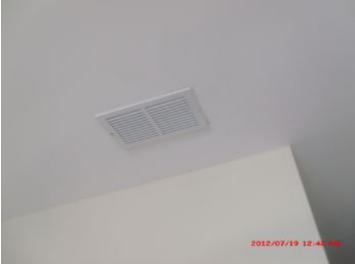
Master bedroom intake register

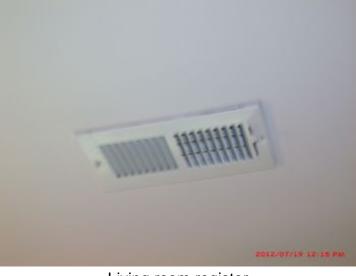
Living room register

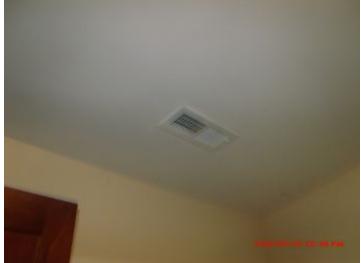
Kitchen register

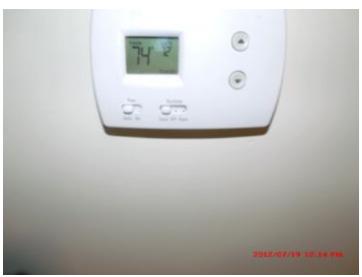
Programmable thermostat

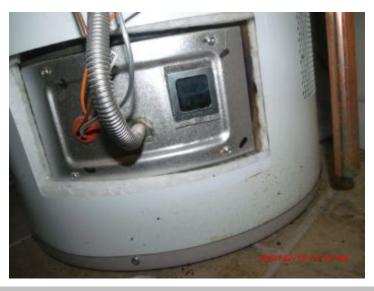
• The water heater base is functional.

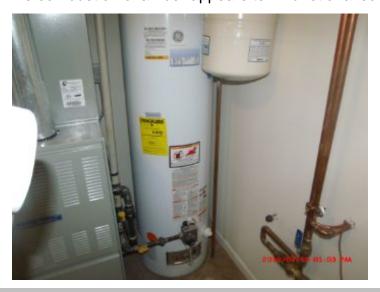
• The combustion chamber appears to in functional condition.

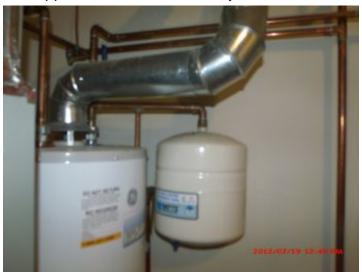
• Tank appears to be in satisfactory condition -- no concerns.

Like new water heater and expansion tank

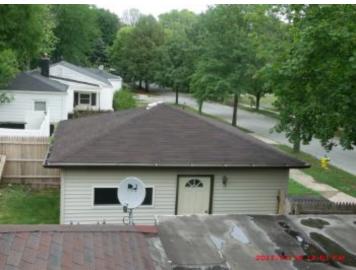
Materials: Asphalt shingles noted.
Observations:
• No major system safety or function concerns noted at time of inspection.

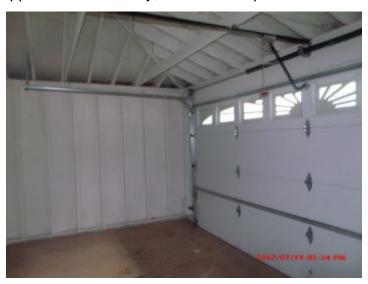
Appeared satisfactory, at time of inspection.

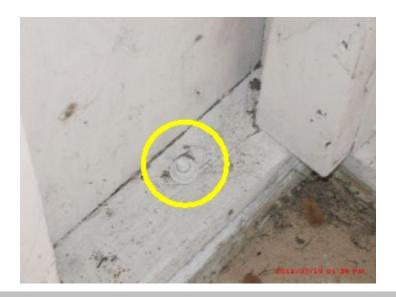
• The anchor bolte were inspected and appear to be serviceable.

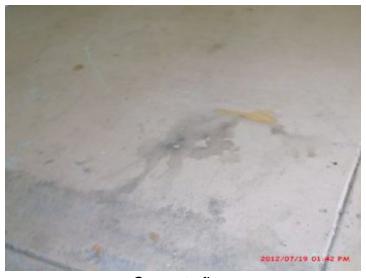
Concrete floor

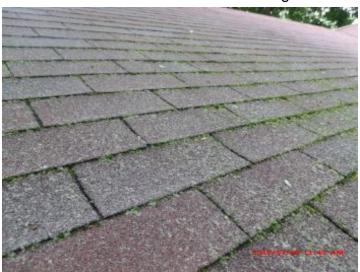
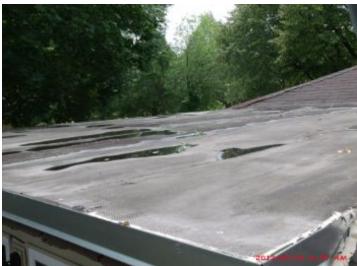
Shingles in good condition

flat top of addition

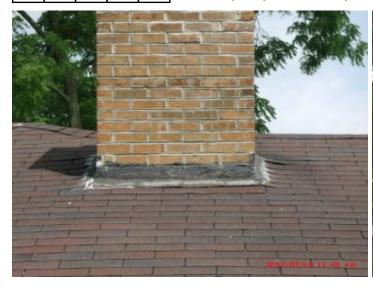
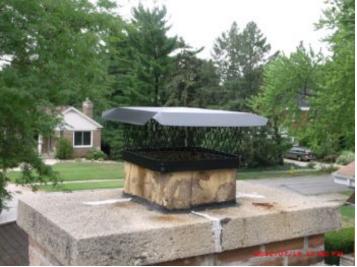
Firepace Chimney cap

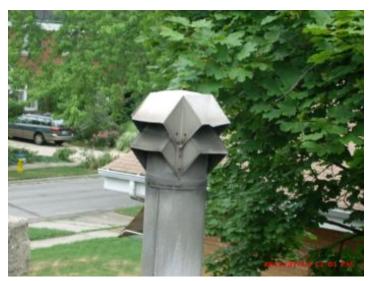
Furnace chimney cap

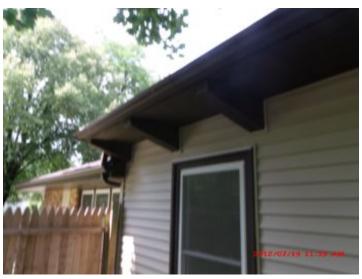
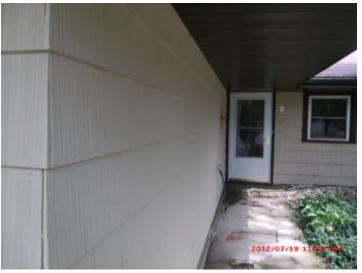
Vinyl siding of addition sunroom

Wood siding on front side of building

Suggest sealing patches to prevent moisture intrusion

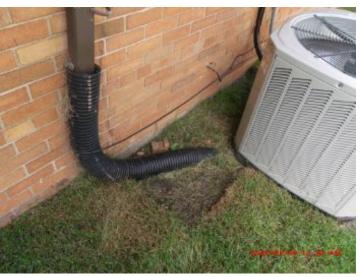
Downspout in rear appears to be blocked. Suggest opening up to deposit away from building

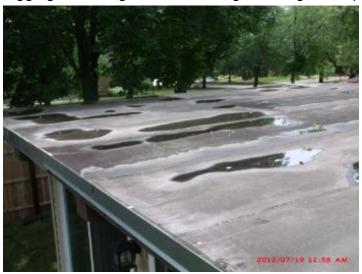
· Sagging / buckling on roof decking, causing water puddling

some water pooling on flat top

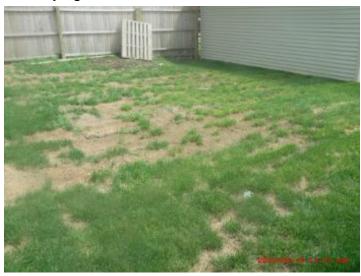
Back yard grass. It appears that some sod did not take

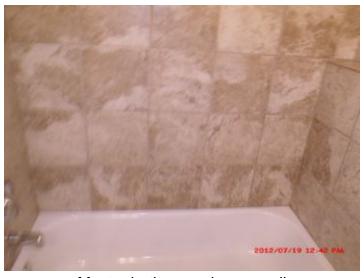
Master bathroom shower wall

Observations:
• Cultured Marble noted.

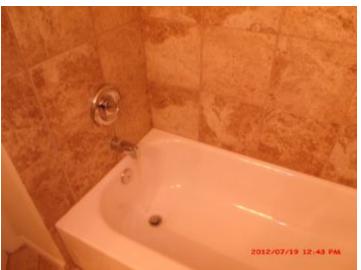
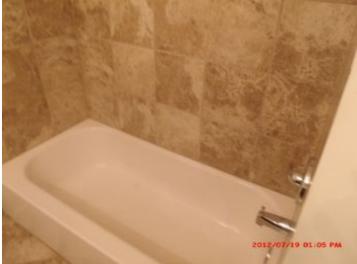
2n bathroom tub

Good	Fair	Poor	N/A	None	Ob
					Observations:
X		l	l		∙ Tub

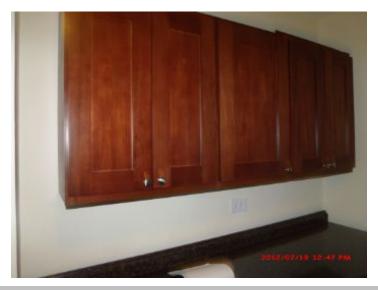
• No deficiencies observed.

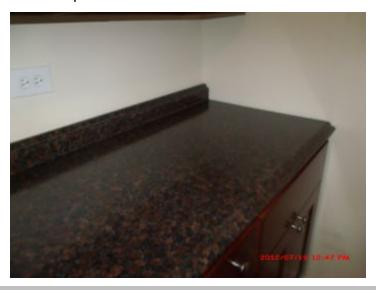
• Granite tops noted.
